Failure Analysis of Heat-Exchanger Sheets at Coke Oven

J. N. Mohapatra¹, Arun Kumar Panda¹ & D. Satish Kumar¹

¹ JSW Steel Ltd. Vijaynagar Works, Bellari-583275, Karnataka, India

Abstract

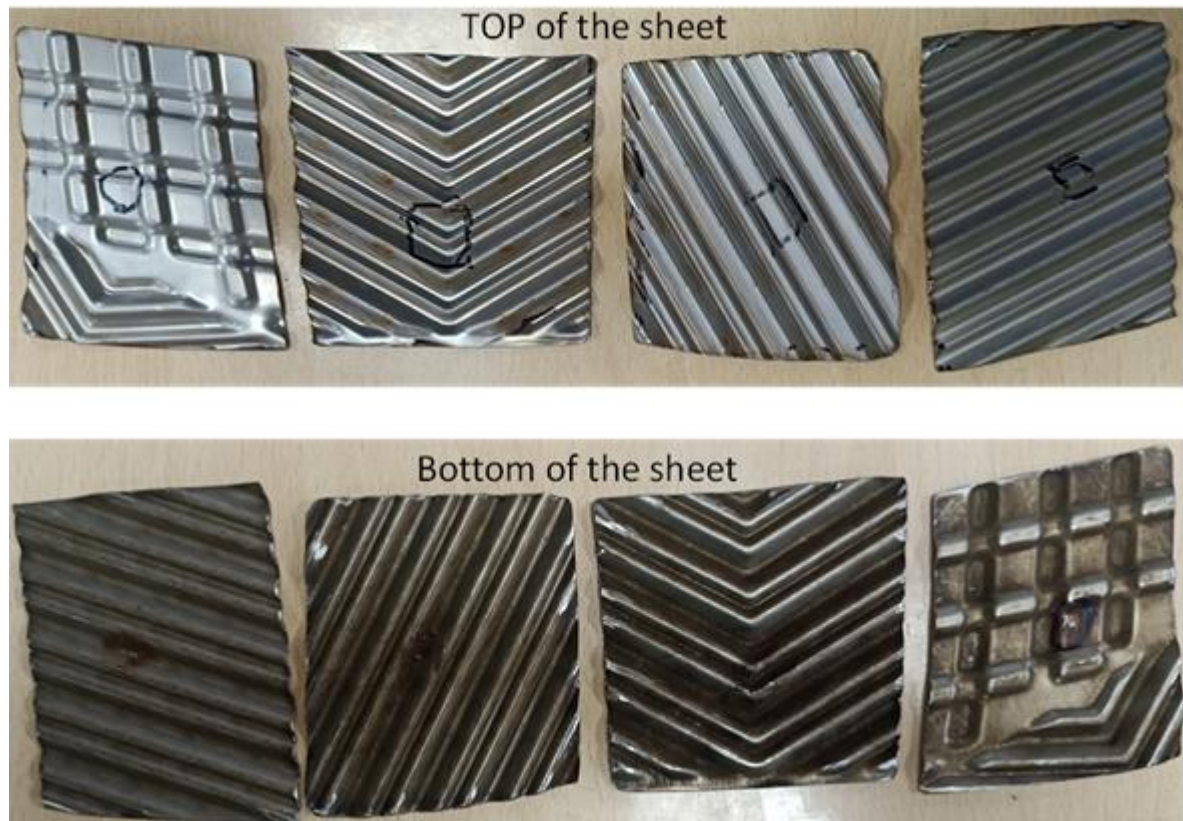
The sheets with the top (extrusion side) and bottom (intrusion side) shown in Figure 1. Pitting marks can be seen on the sheets surface responsible for the leakages.

Figure 1. Heat exchanger plates received from JSW coke oven with pitting marks on it

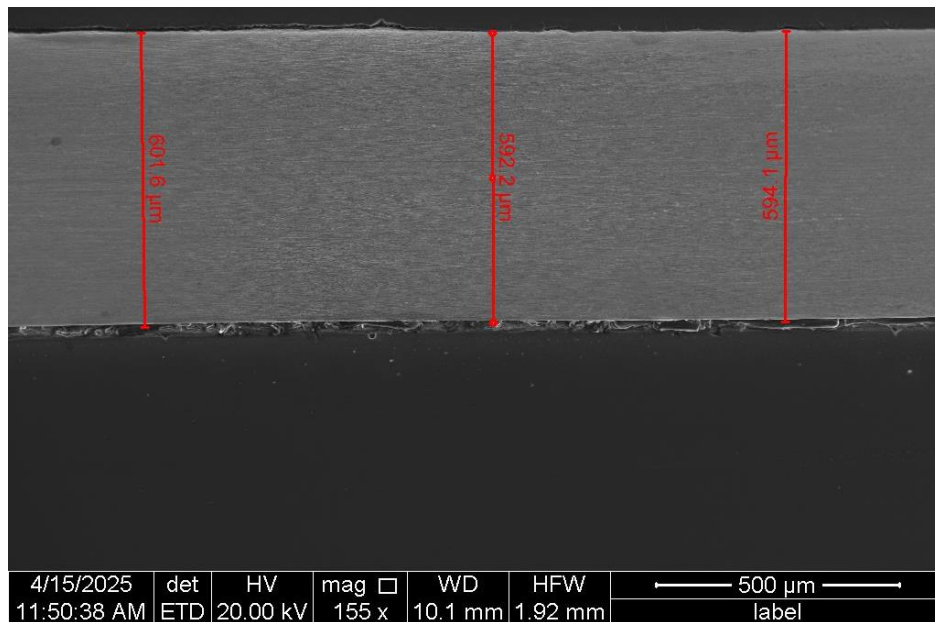
Chemical composition of the sheets is shown in Table 1. The chemical composition shows a small deviation in Ni content in the sheets (lower-9.3-9.6 wt. % Ni) compared to the specification (10-13%). Thickness of the sheets measured through SEM is shown in Figure 2. The thickness of the sheets were found to be in the range of 0.592-0.601mm. Micro hardness of the sheets are shown in Table 2. As per the specification the hardness has to be 217 BHN which is 222Hv0.5kgf. It can be seen that the hardness is different at different regions varying in the range of 189-249 Hv0.5kgf, indicating presence of hard and soft phases in the sheet leading to different level of hardness.

Figure 2. Thickness of the heat exchanger sheets measured through SEM

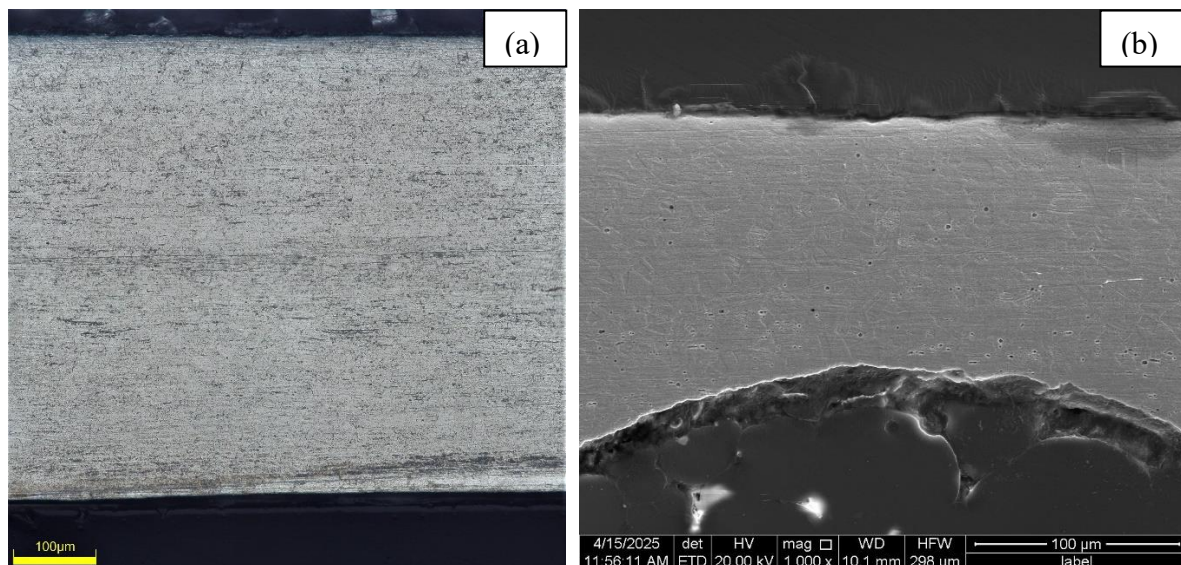
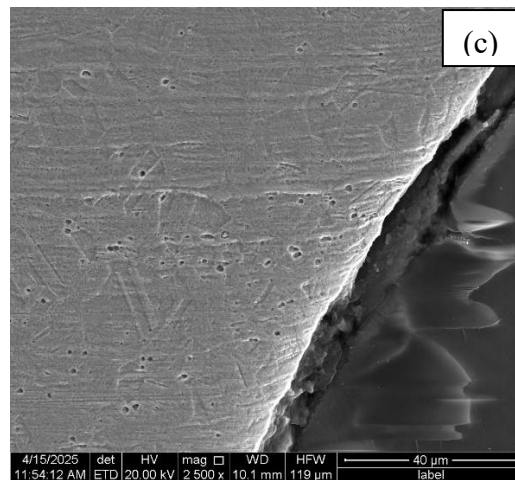
Microstructure of the sheet is shown in Figure 3 (a) with the SEM micrographs in (b) and (c) respectively. Small pits can be seen on the sheets at high magnification SEM micrograph (Figure 3(c)). Corrosion pits can be seen in un-etched and etched condition as shown in Figure 4 (a) and (b) respectively. SEM micrograph of the sheets with the corrosion pits are shown in Figure 5. It can be seen that some of the pits are not having through hole whereas some are having through holes.

Figure 3. (a) Optical microstructure, (b) SEM micrograph and (c) high magnification SEM micrograph of the heat exchanger sheets

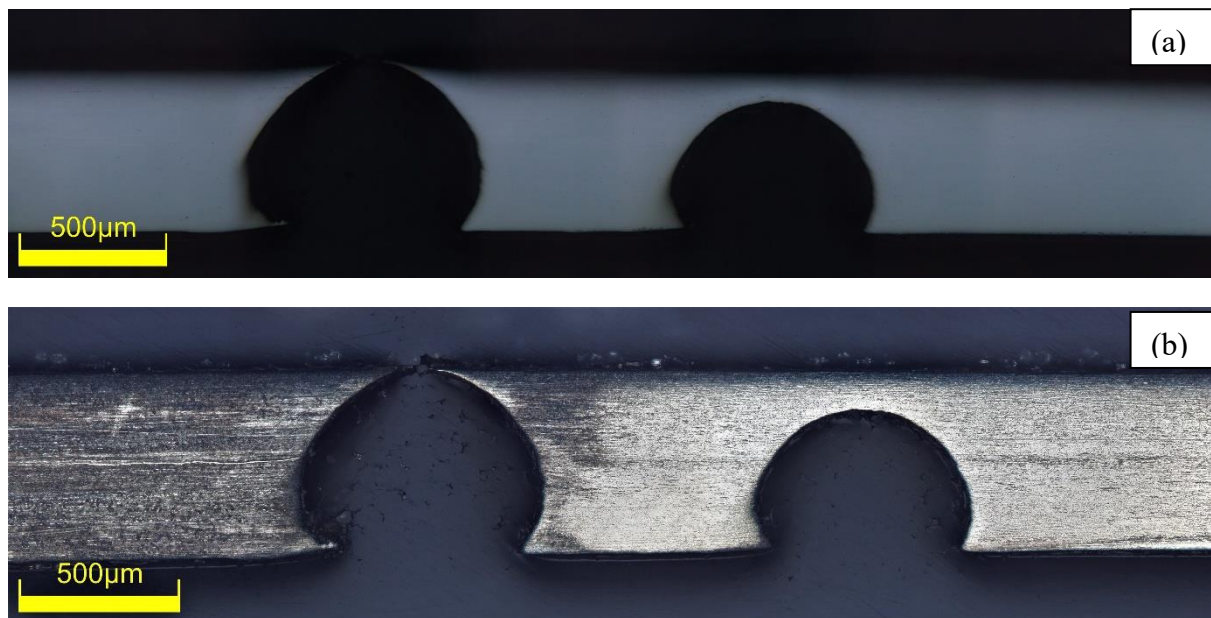
Figure 4. Corrosion pits on the sheet (a) un-etched and (b) etched condition

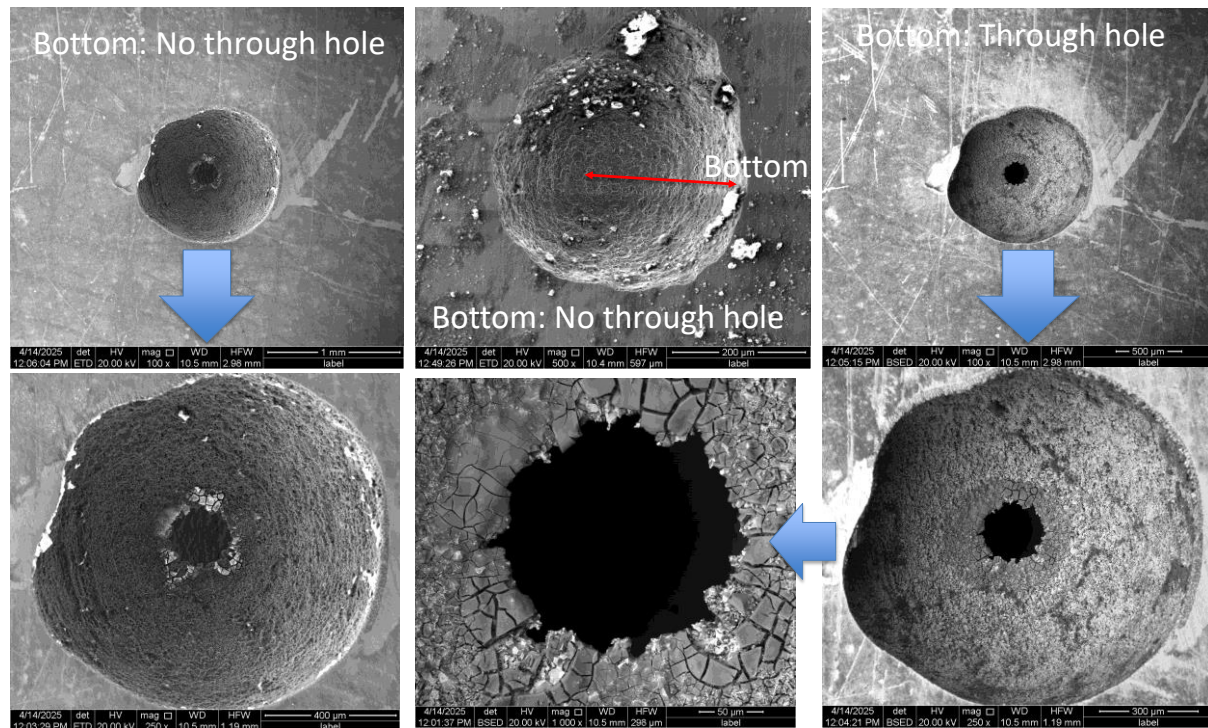
Figure 5. SEM micrograph of the pits with through hole on the sheet and partial pits

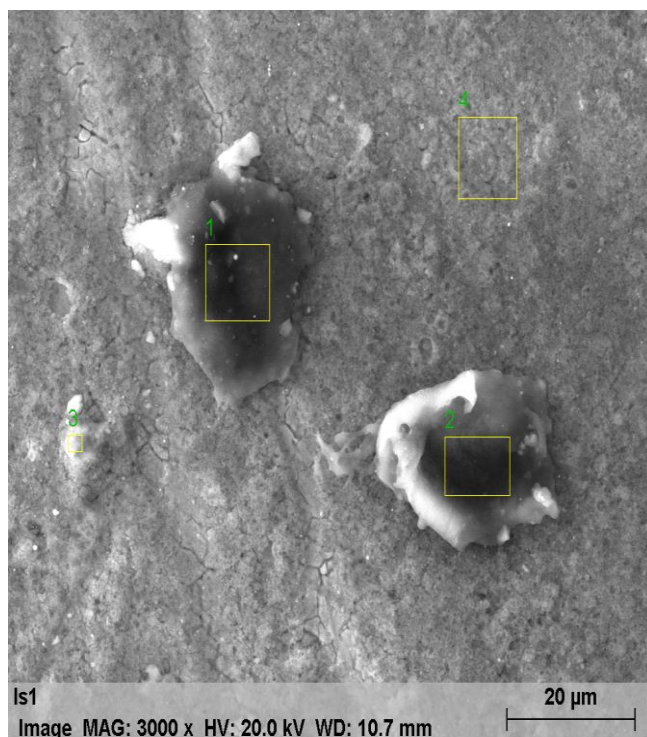
SEM EDS of the on the sheets near to the pits and away from the pits are shown in Figure 6 and 7 respectively. It shows presence of chloride near to the pits and such chlorides are in very high level found away from the pits. It indicates that the high level of chloride responsible for the pitting corrosion of the sheets. The source of the chloride was found to be the water. The higher level of chloride in the water leading to pitting corrosion of the sheets.

Figure 6. SEM-EDS analysis revealing presence of chloride on the sheet surface near to pit

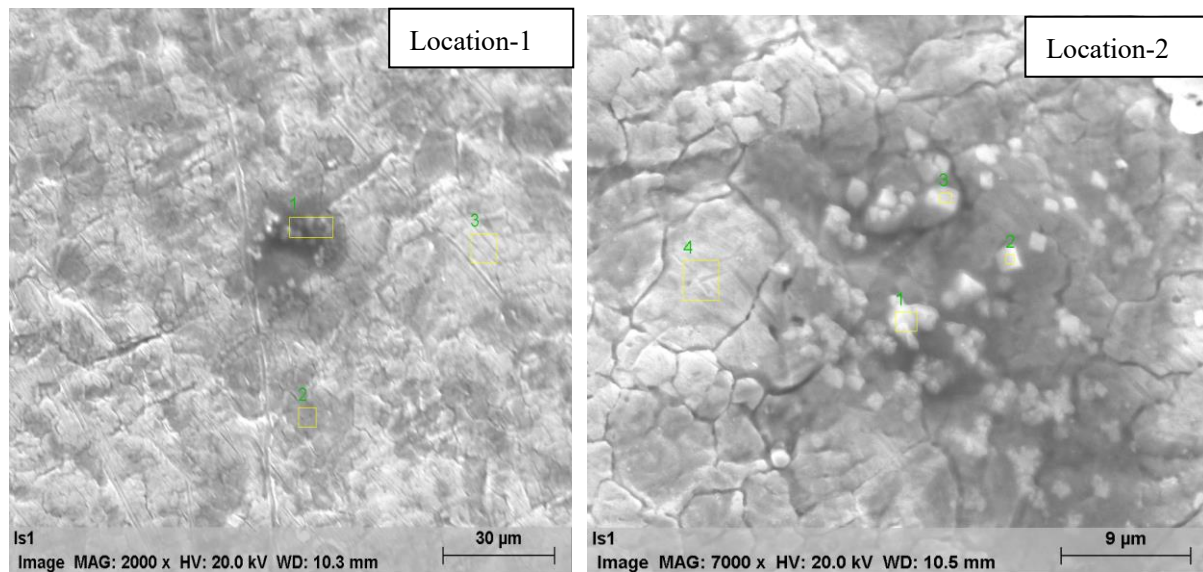
Figure 7. SEM EDS revealing presence of high level of chloride on the sheet surfaces away from the corrosion pit

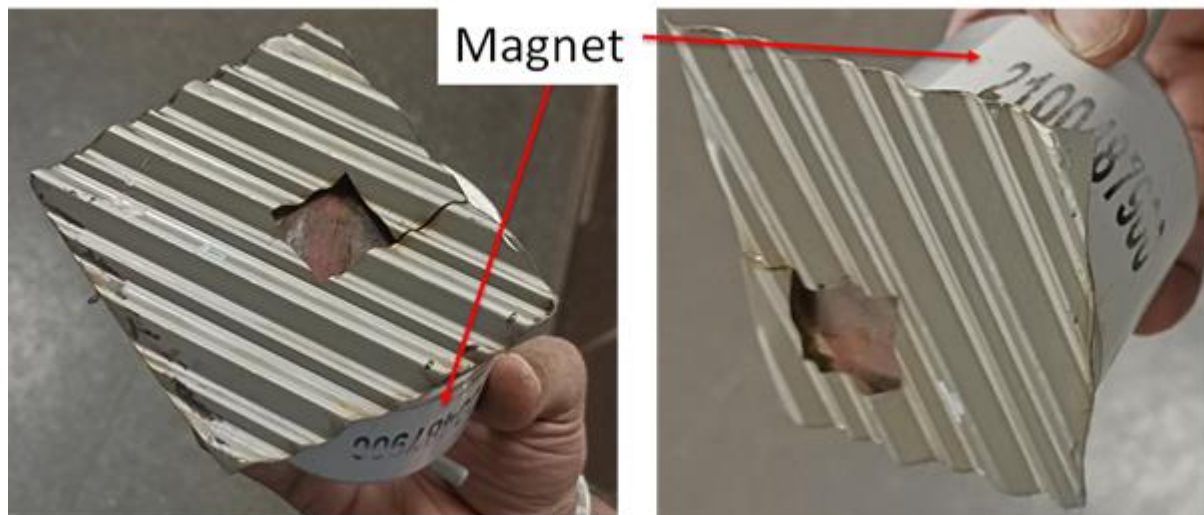
A permanent magnet was used to check the magnetic properties of the sheets. Figure 8 shows that the sheets are getting attracted by a permanent magnet. Generally 316L steel is non-magnetic in nature due to the fully austenitic phase. As it is getting attracted by a magnet, it indicates presence of ferromagnetic phase such as martensite in the steel. Figure 9 Shows formation of hysteresis loop on the sheet with the application of cyclic magnetic field through a magnetic NDE device (*MagStar*) indicating presence of ferromagnetic phase on the sheets. Such martensites are generated due to transformation of austenite to martensite due to severe plastic deformation during the manufacturing stage. However, after deformation the sheets need to be annealed above the A_3 temperature to remove the martensites, which has not been done in the present case.

Figure 8. Permanent magnet shows attraction of the sheets indicating presence of magnetic phase (Martensite)

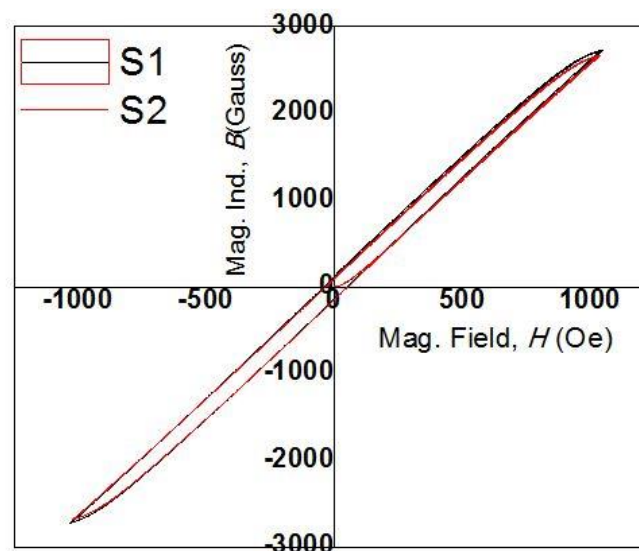
Figure 9. Hysteresis loop formed on the sheets with a portable magnetic NDE device indicating presence of ferromagnetic phase (Martensite) in the sheets
